AFML-TR-76-81-PT-4

DEFECT-PROPERTY RELATIONSHIPS IN COMPOSITE MATERIALS

K. L. Reifsnider, E. G. Herneke, II and W. W. Stinchcomb

Final Report

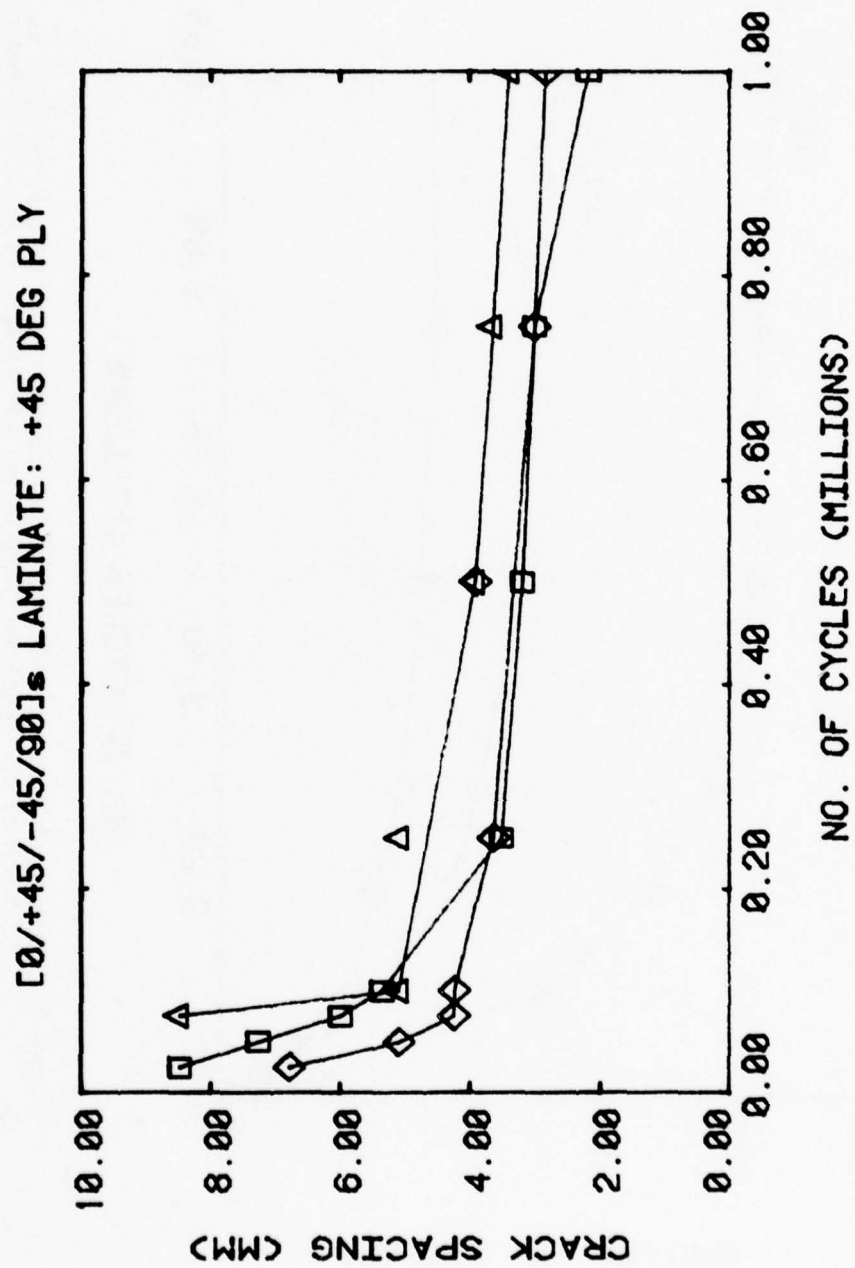
Figure 22. Crack Spacings as a Function of Cycles of Loading at 40 ksi (275.6 MPa) in the +45° Plies of Several Type I Laminates

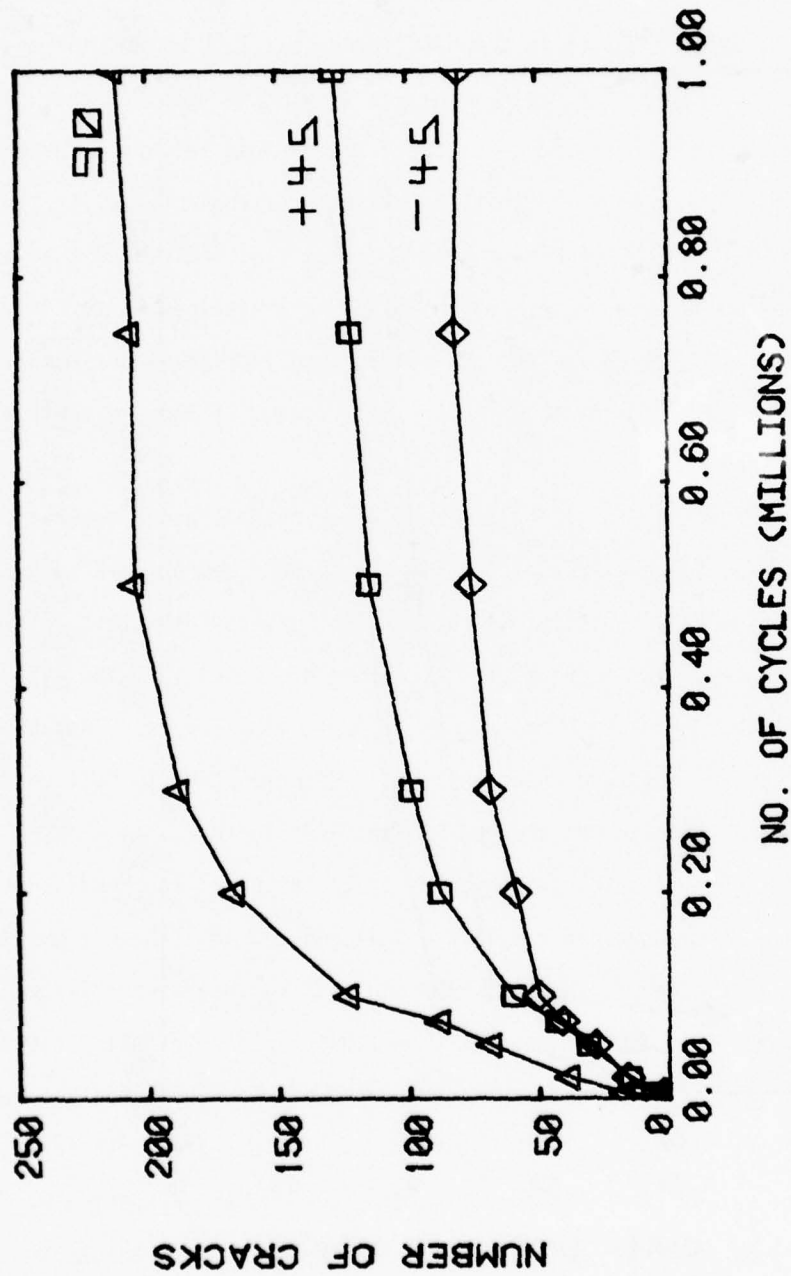
Figure 23. Number of Observed Cracks as a Function of Cycles of Loading at 40 ksi (275.6 MPa) for Specimen II-20 in the 90° plies (top curve), +45° plies (middle curve) and -45° plies (bottom curve).

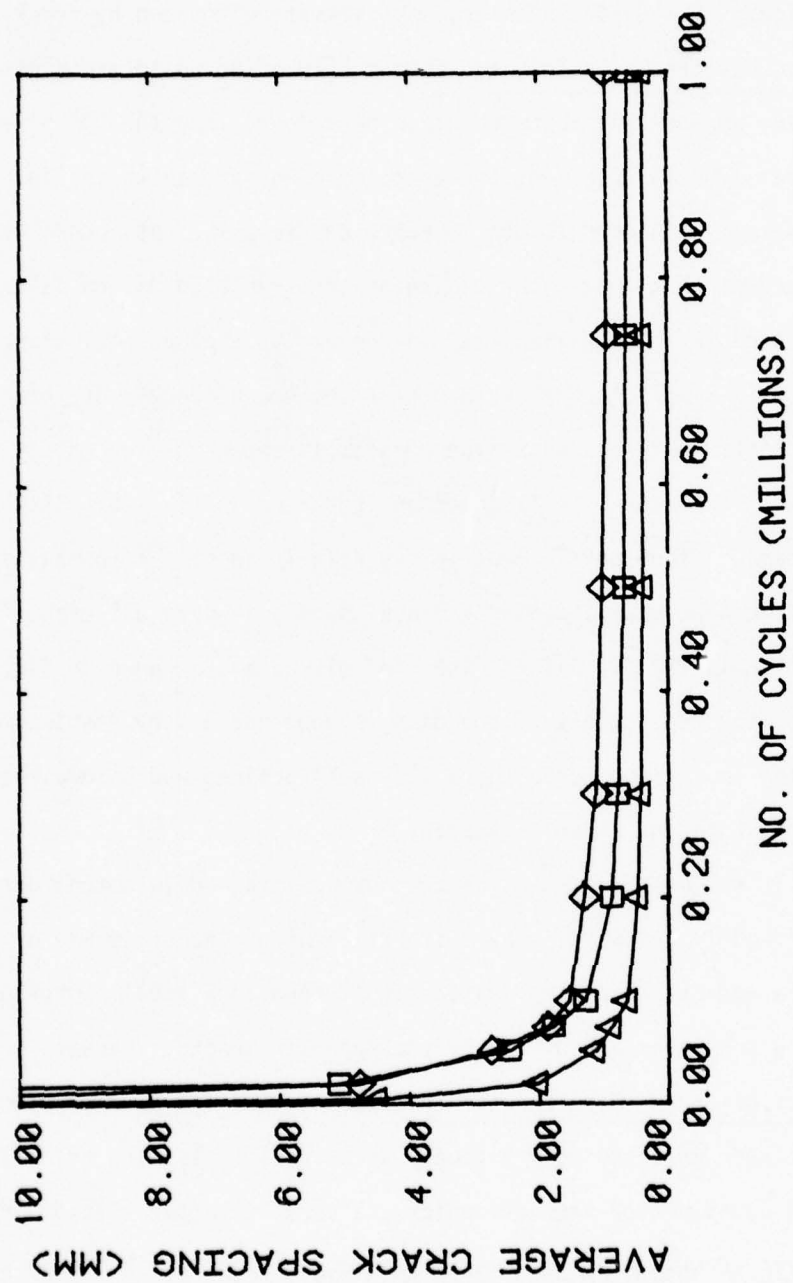
Figure 24. Spacing of Cracks as a Function of Cycles of Loading for Specimen II-20 in the 90° (bottom), +45° (middle) and -45° (top) Plies

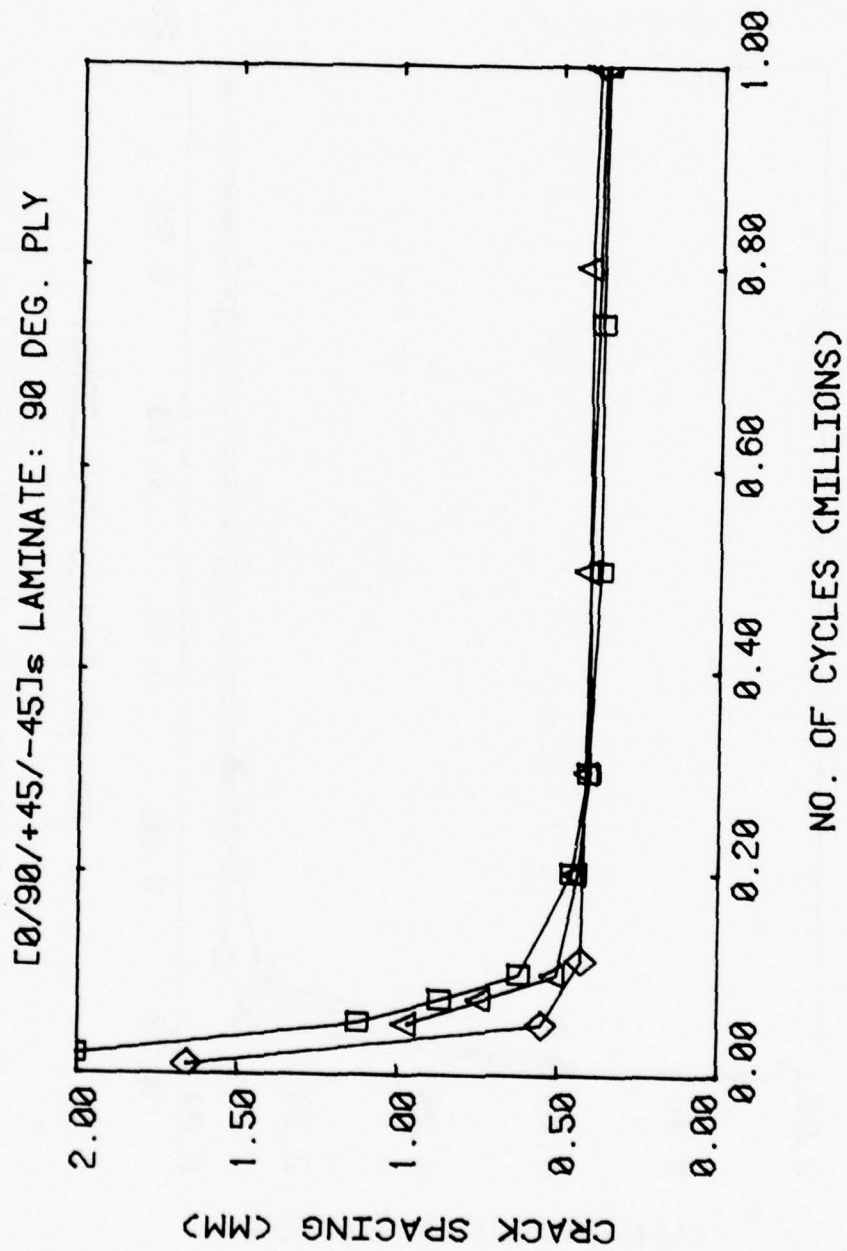
Figure 25. Crack Spacings in the 90° Plies of Several Type II Specimens as a Function of Cycles of Loading

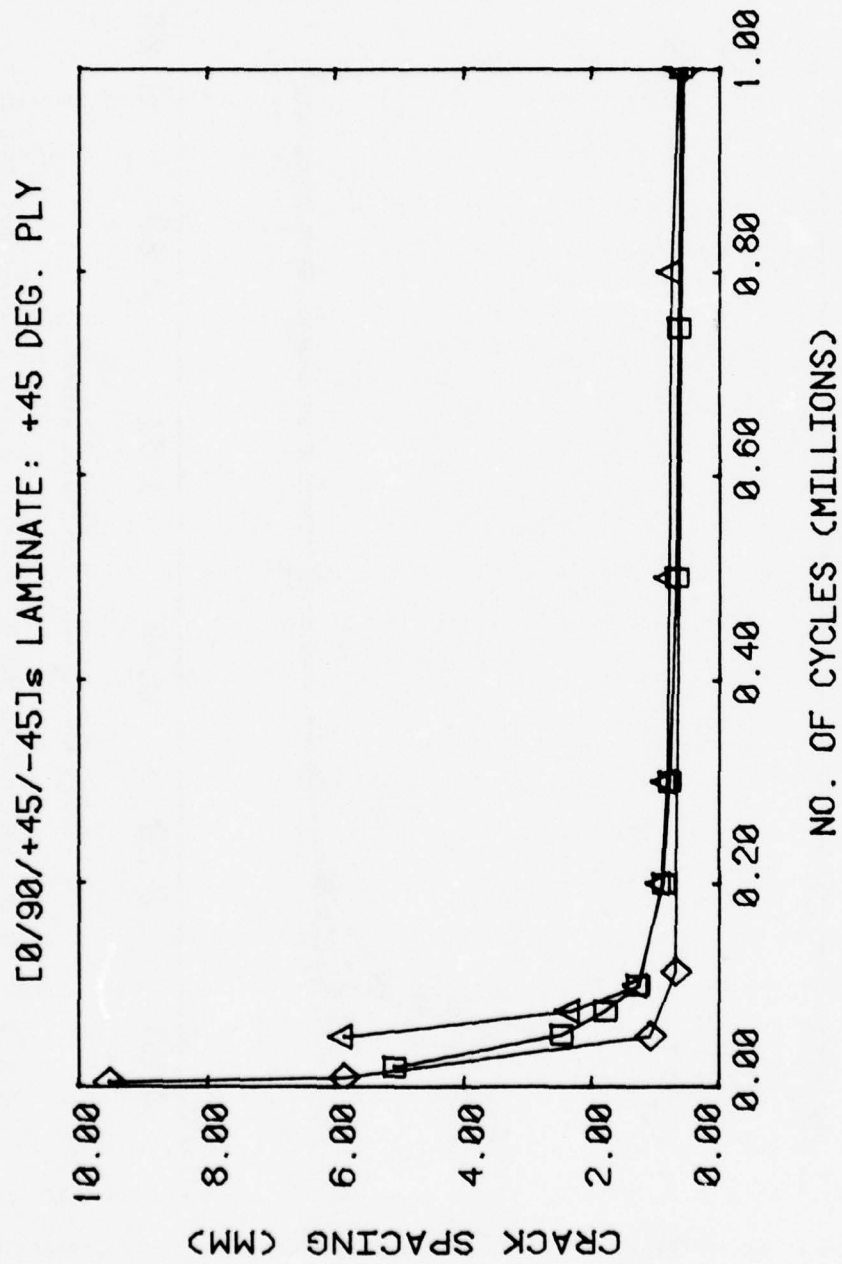
Figure 26. Crack Spacings in the +45° Plies of Several Type II Specimens as a Function of Cycles of Loading

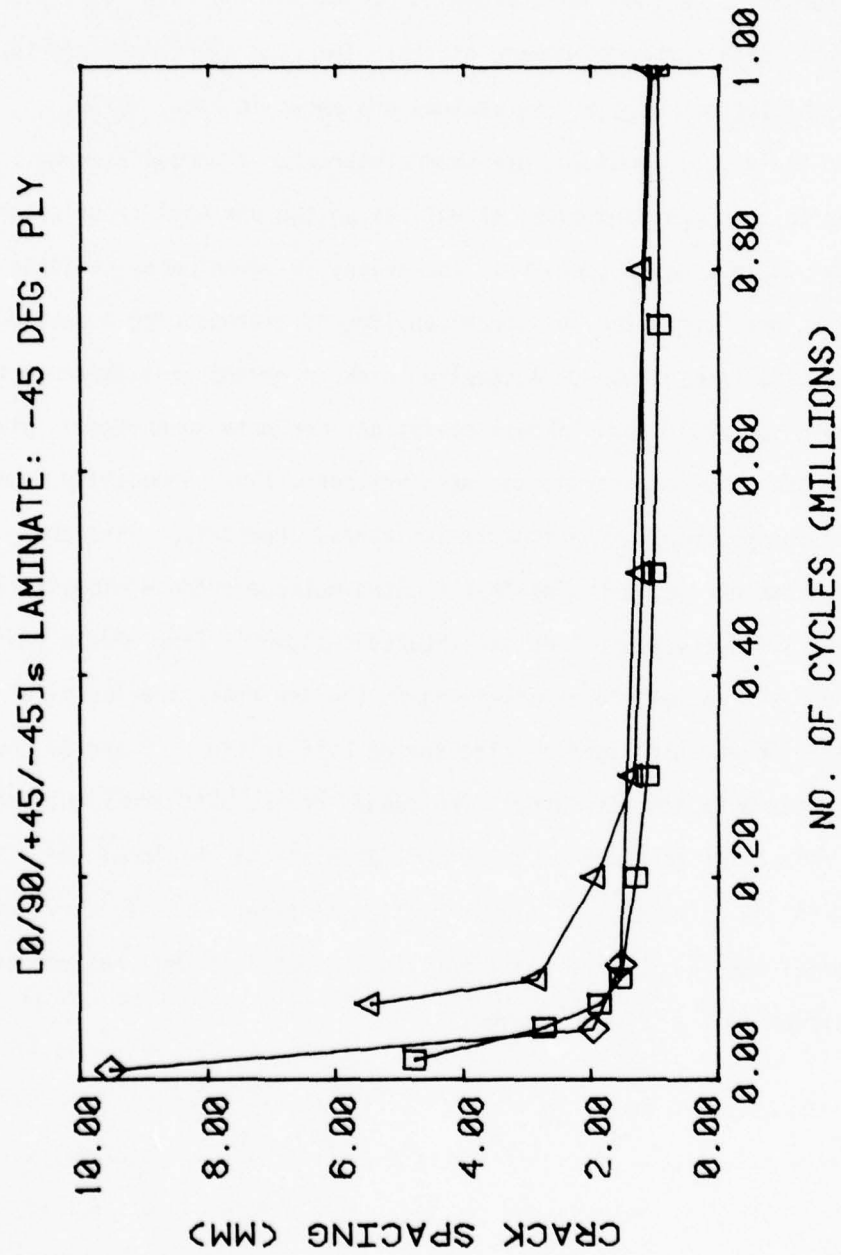
Figure 27. Crack Spacings in the -45° Plies of Several Type II Specimens as a Function of Cycles of Loading

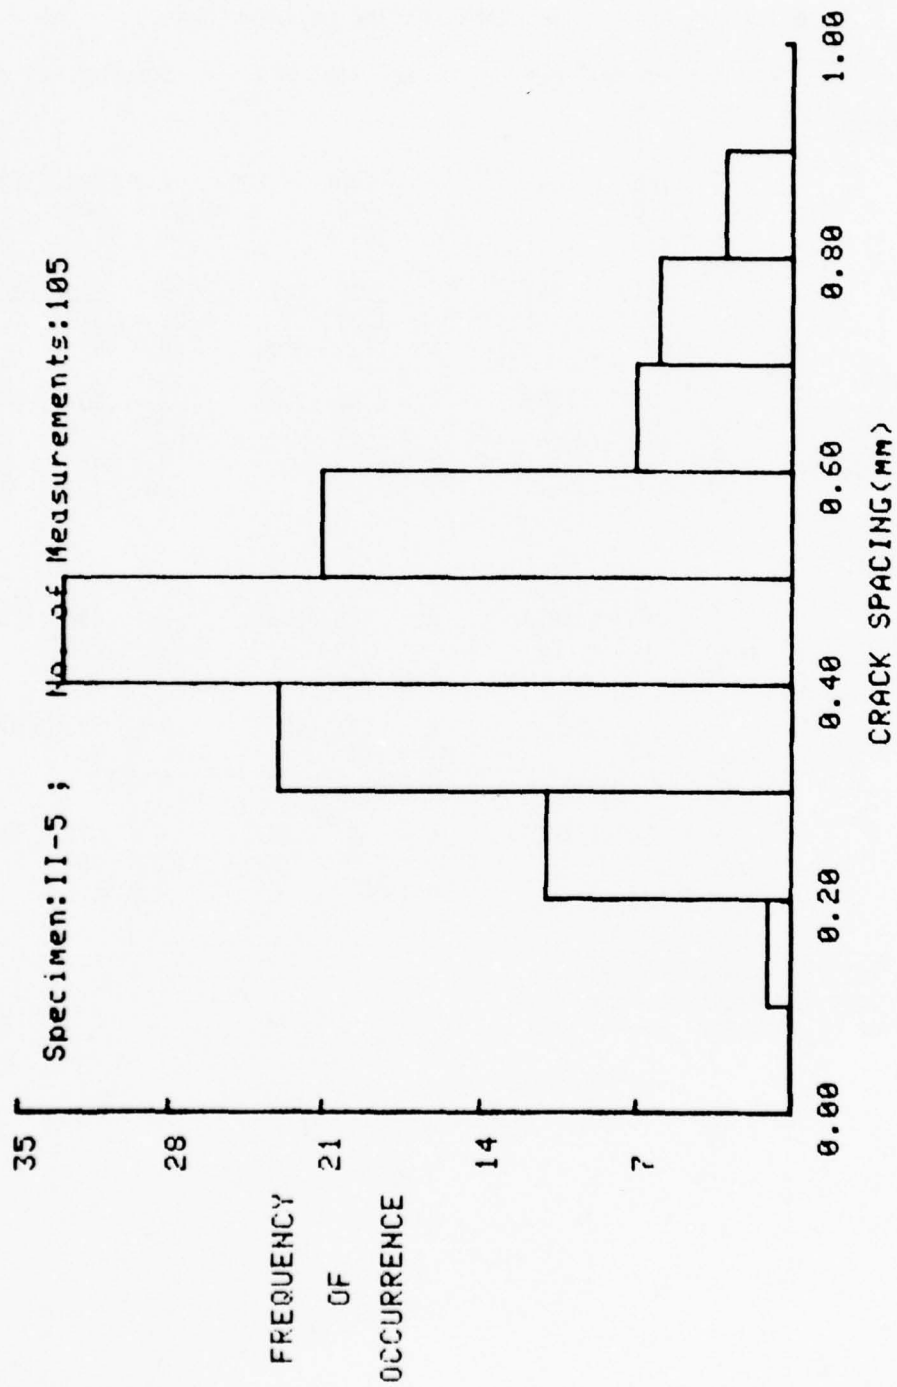
Frequency of Occurrence vs. Crack Spacing (mm) in +45 deg. Lamina of [0/90/+45]s Laminate II-5 (I) at 1 M cycles Lb. fatigue Load.

Figure 28. Histogram of Crack Spacings for Measurements from +45° Laminae of a Type II Laminate

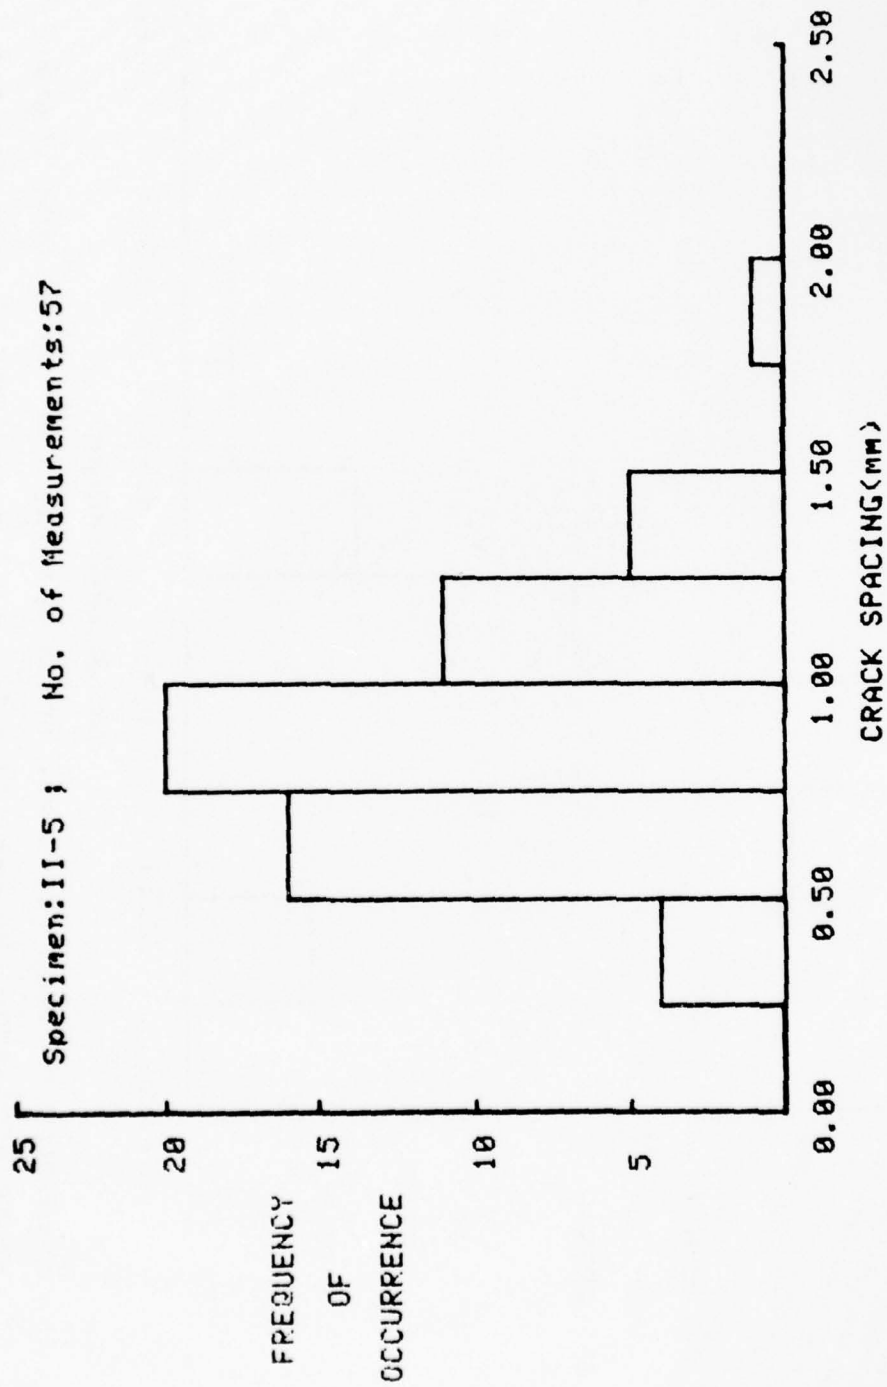
Frequency of Occurrence vs. Crack Spacing (mm) in -45 deg. Lamina  
of [0/90/+45]s Laminate II-5 (I) at 1 M cycles Lb. fatigue Load.

Figure 29. Histogram of Crack Spacings for Measurements from -45° Laminae of a Type II Laminate

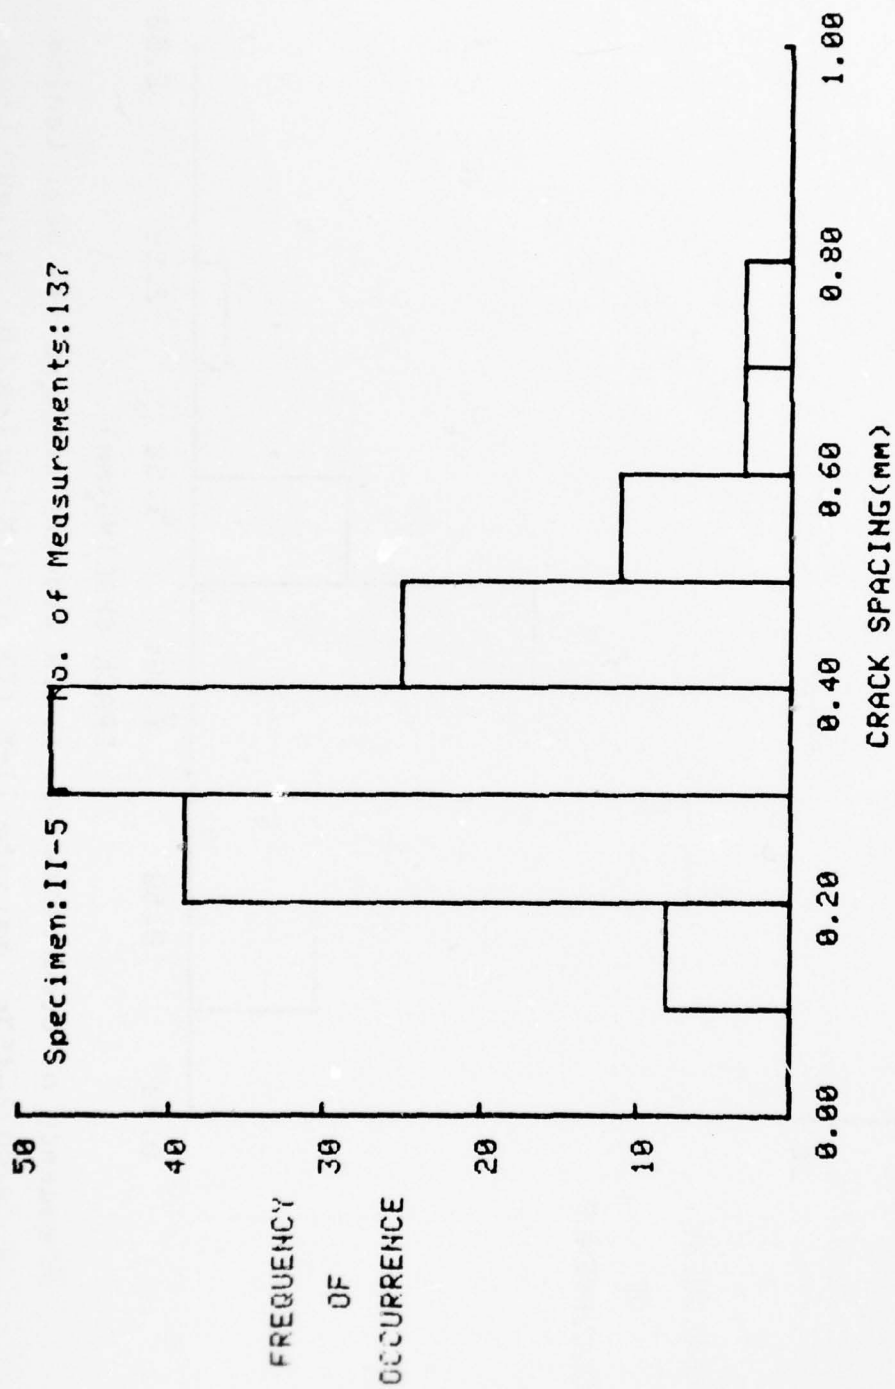
Frequency of Occurrence vs. Crack Spacing (mm) in 90 deg. Laminae of [0/90/+45]<sub>s</sub> Laminate II-5 (I) at 1 M cycles Lb. fatigue Load.

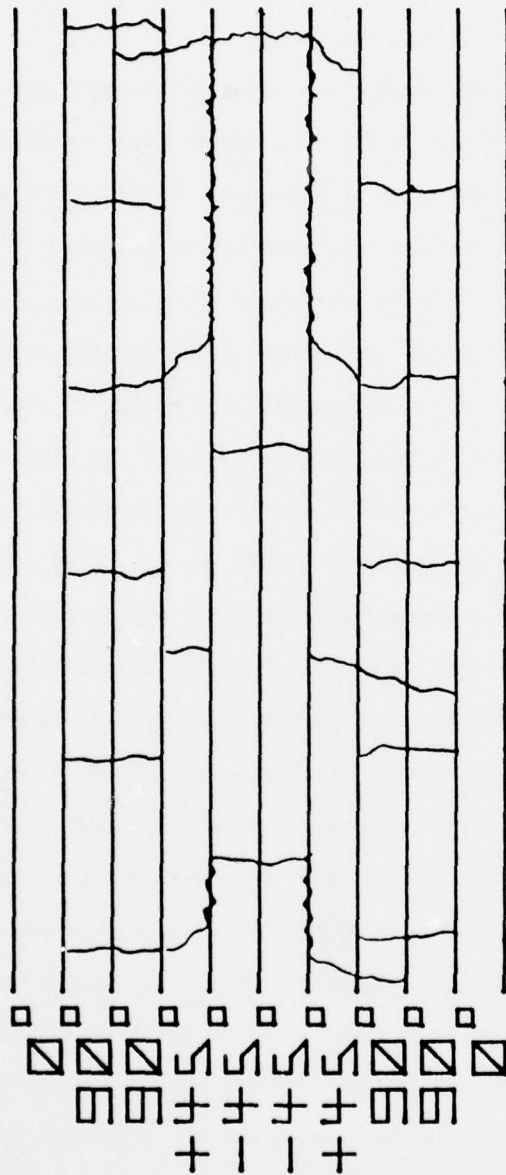
Figure 31. Schematic Diagram of Crack Patterns in a Type III Laminate

Another interesting comparison is the strength of Type II and III laminates. Although we have relatively inconclusive data (due to only a limited number of ultimate strength tests) it would appear that the ultimate strength of the Type III laminates is low, especially in comparison to the Type II laminates. Figure 31 shows another aspect of growth in

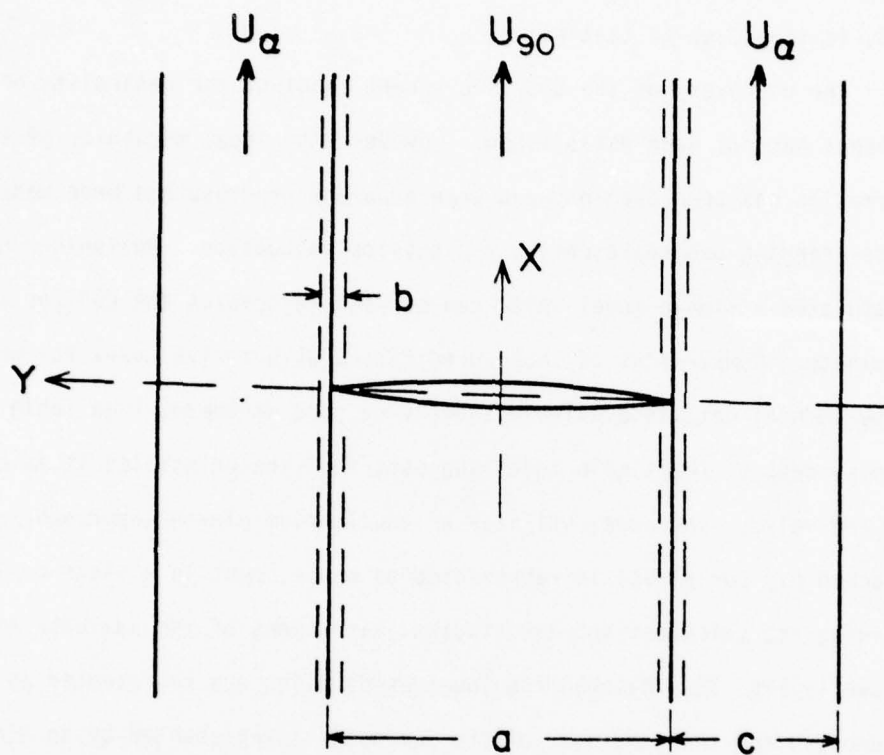
Figure 32. Equilibrium element used for one-dimensional model of characteristic damage state formation

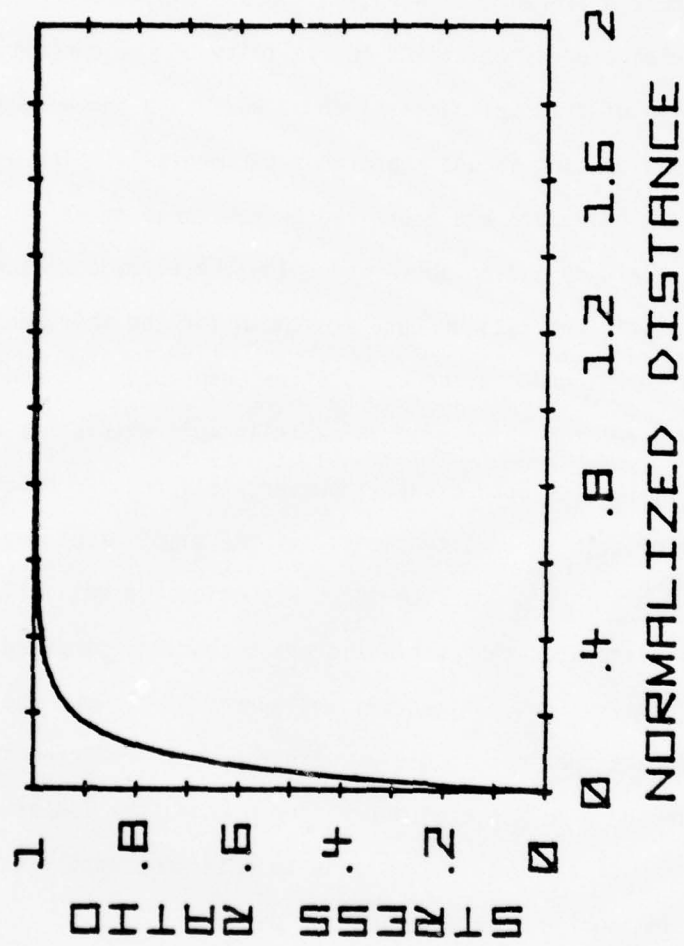
$E_{x90} = 9.17$  GPA,  $E_{x0} = 142.7$  GPA in the analysis. A plot of normalized stress verses normalized distance from the crack face is shown in Fig. 33 for this case. In order to establish a value of  $x$  at which the stress reaches the undisturbed value one must either pick a discretionary value off of the plot or return to the equations and set a specific

Figure 33. Normalized Stress as a Function of Distance from the Crack Face Predicted by the Analysis.

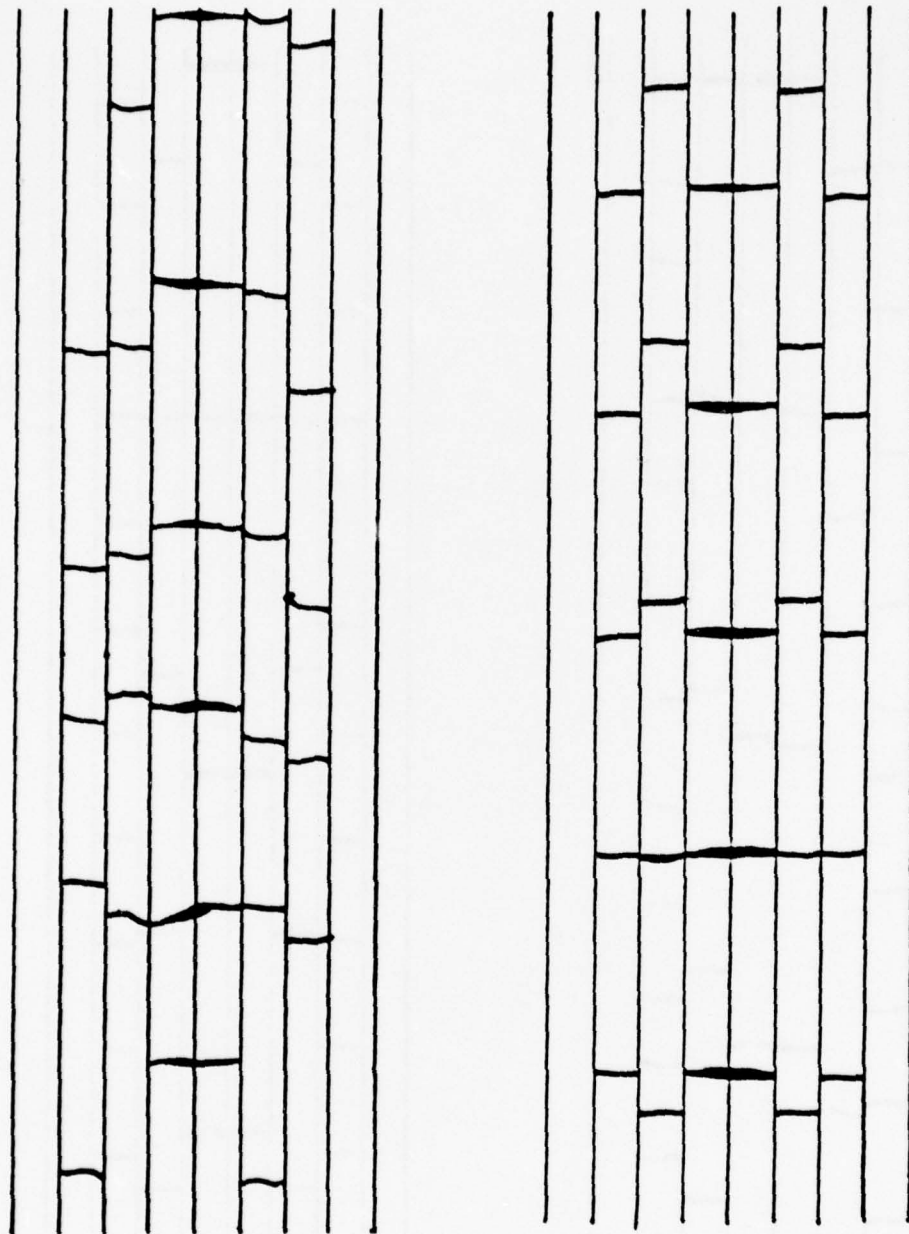
damage states. The observed state for Type I laminates is shown by the typical pattern on the top of Fig. 34 and the predicted state is shown on the bottom. The basic features are faithfully reproduced by the analysis. Figure 35 shows the same type of comparison for a Type II laminate. Aside from the fact that the analysis appears to predict the CDS well in both cases, it is important to notice how different the damage states are when the stacking sequence, only, is changed. The  $90^\circ$  plies for example, have nearly twice the density of cracks in the Type II laminate as they do in the Type I configuration. This difference might be expected to produce a difference in properties. It is, in fact, so. The strength of the Type I laminate, for example, is consistently lower than that of the Type II material (delamination of the Type I laminates may contribute to this difference). Transverse cracks also reduce the laminate stiffness so that a difference in crack densities will also mean a difference in stiffness change. Finally, during fatigue loading at stress levels of half the ultimate strength up to about two thirds of that value, the CDS of the laminate usually develops fairly completely. It becomes, then, a well defined damage state which can be modelled carefully and accurately, a state which controls the state of strength and state of stress from which the final fracture event develops. Hence, it is very desirable to be able to predict the CDS for arbitrary laminates. It would appear that even the very simple analysis discussed above can capture the essential features of the CDS, at least raising the possibility that we can anticipate the fatigue damage state for any laminate. The generality of the method is suggested by the comparisons shown in Table 8 and by the predictions shown by the straight horizontal

Figure 34. Observed (top) and Predicted (bottom) Characteristic  
Damage State for Type I Laminate

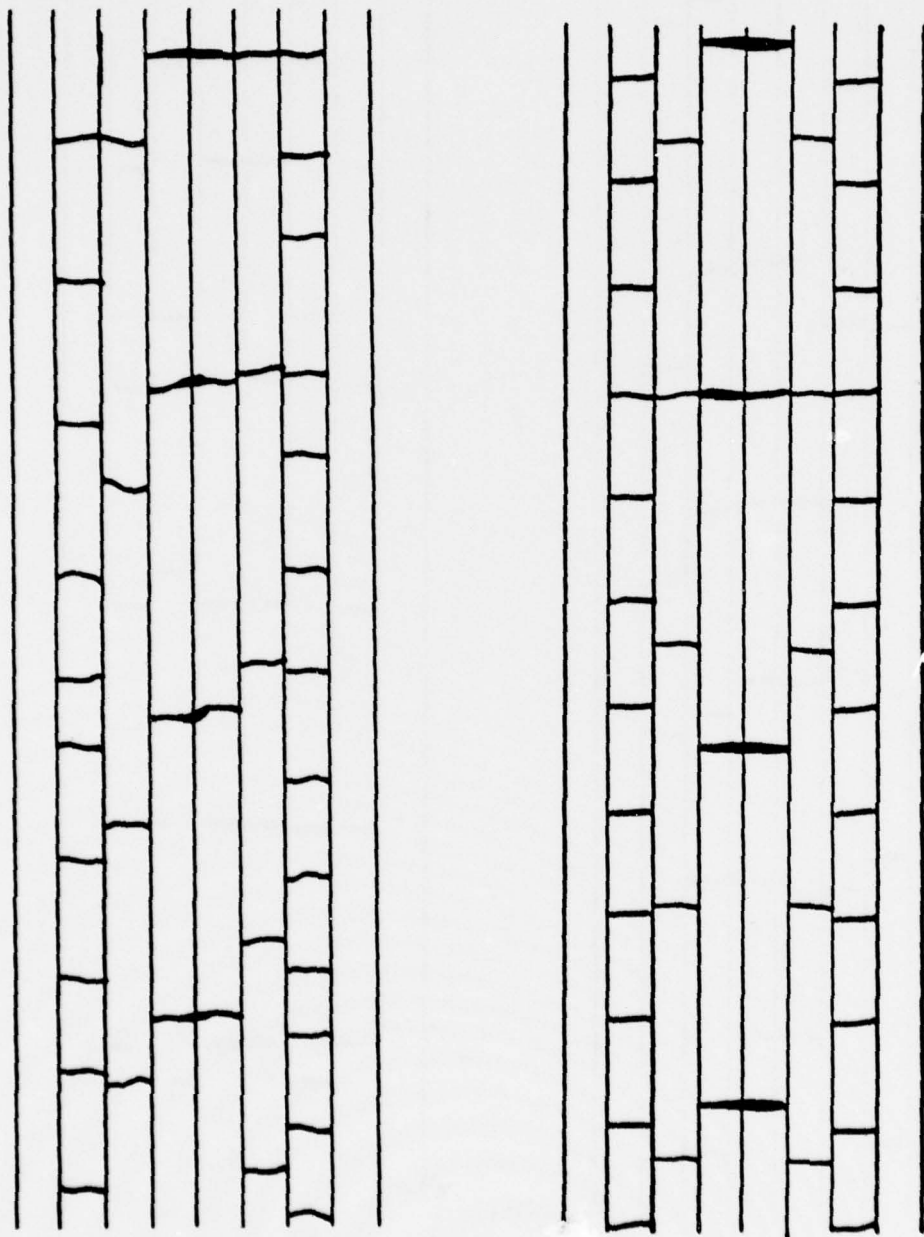
Figure 35. Observed (top) and Predicted (bottom) Characteristic  
Damage State for Type II Laminate

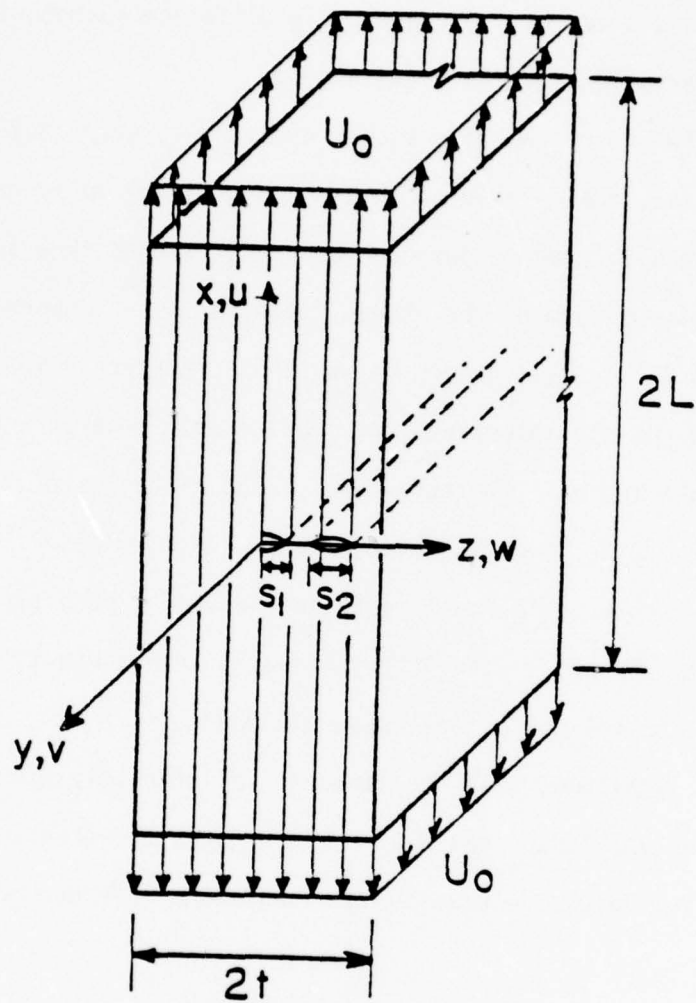
Figure 36. Schematic diagram of the cracked laminate

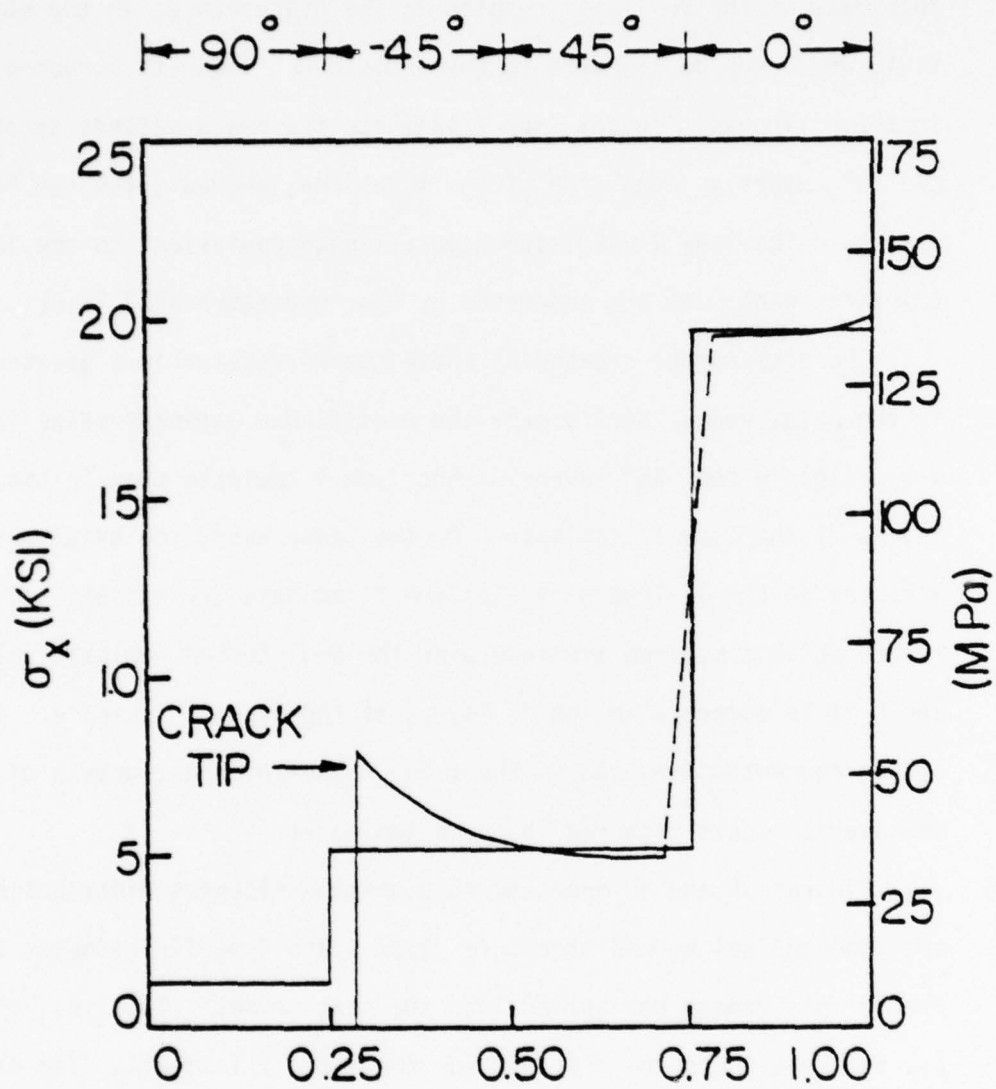
Figure 37. Through-the-thickness variation of  $\sigma_x$  for a type I laminate with  $90^\circ$  ply damage

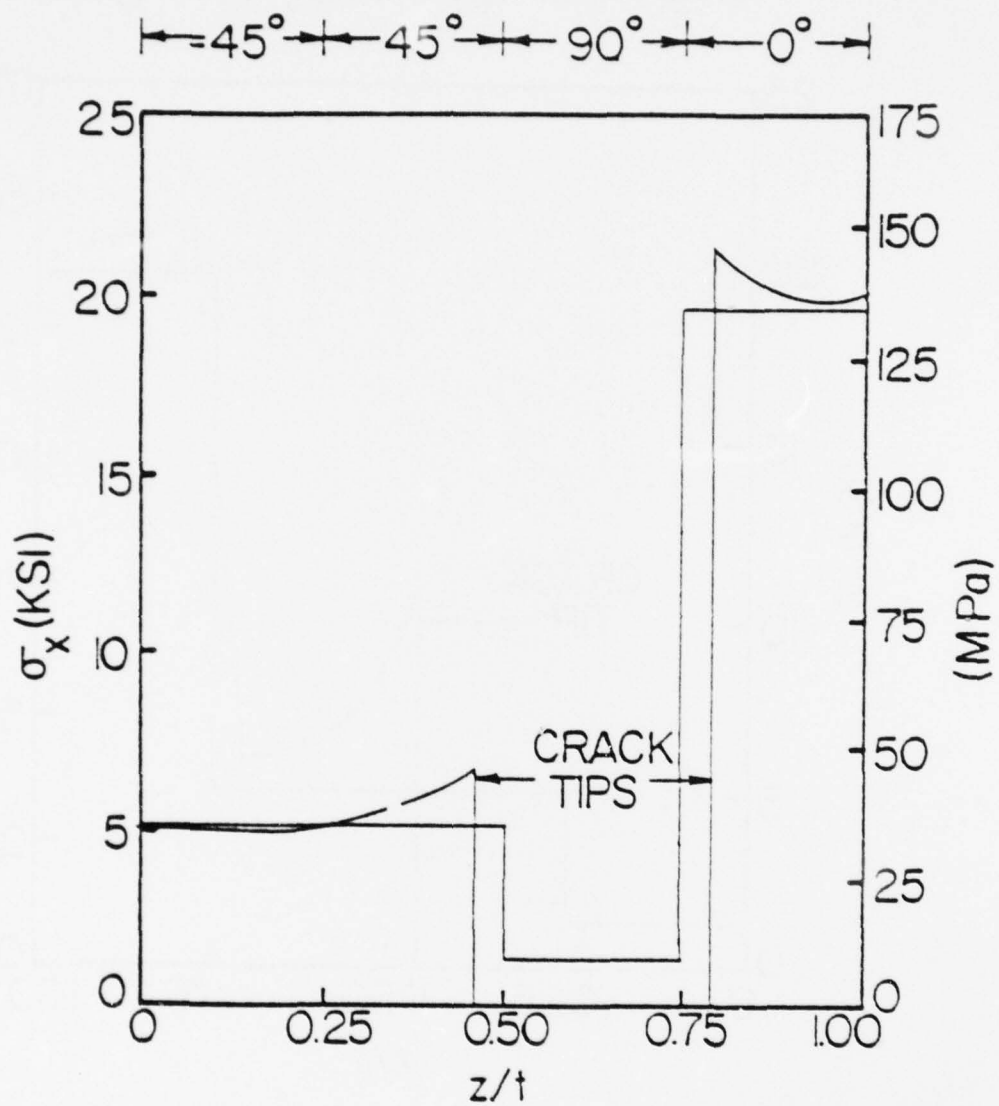
Figure 38. Through-the-thickness variation of  $\sigma_x$  for a type II laminate with 90° ply damage

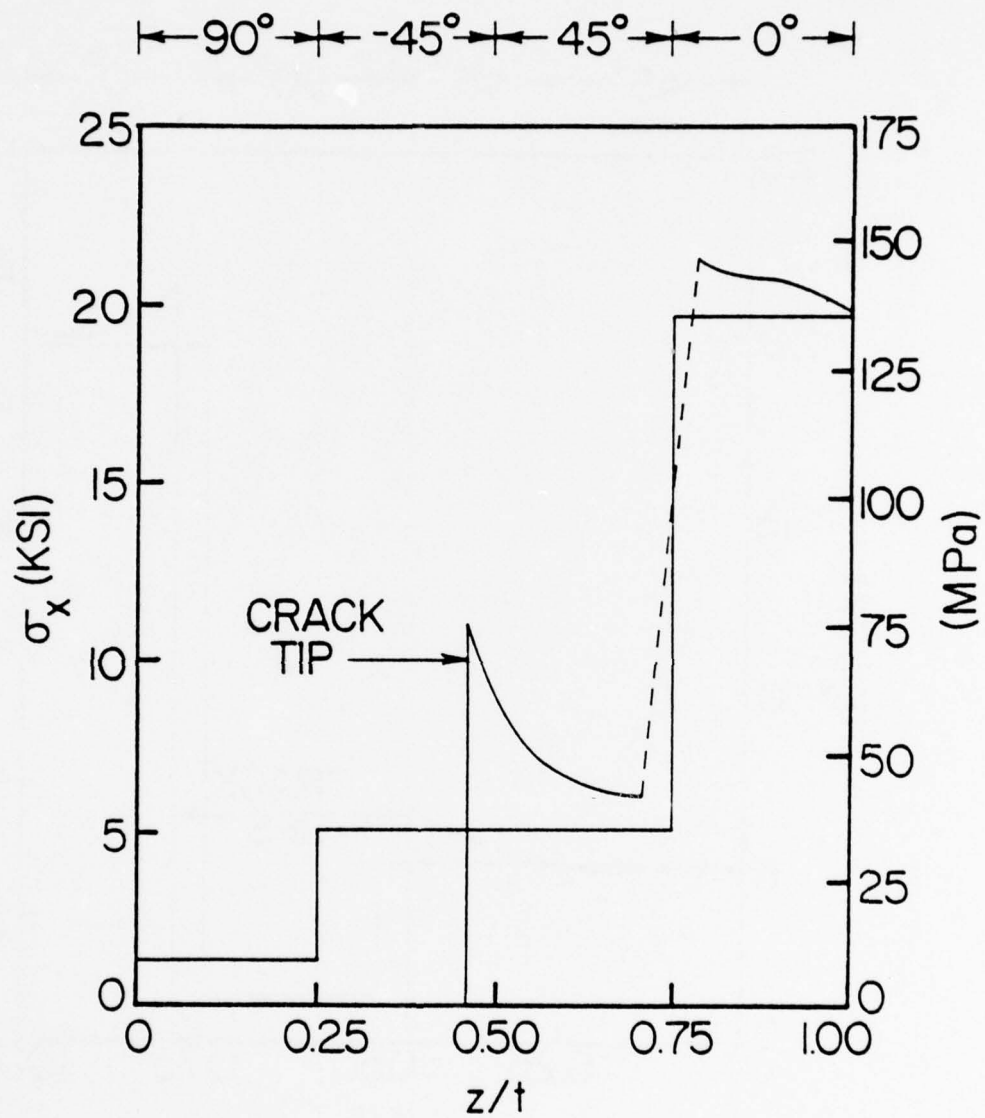
Figure 39. Through-the-thickness variation of  $\sigma_x$  for a type I laminate with 90° and -45° ply damage

Figures 39 and 40 show the through-the-thickness distribution of the longitudinal normal stress for Type I and Type II laminates after the  $90^\circ$  ply damage has spread into the next weakest ply, i.e., the  $-45^\circ$  ply for Type I and the  $+45^\circ$  ply for the Type II laminate. The damaged laminate stresses increase with increasing crack length under constant strain as expected. In the Type I laminate, extending the crack through the  $-45^\circ$  ply is observed to cause not only a greater increase in the crack tip stress within the adjacent  $45^\circ$  ply, but also more than an 8%

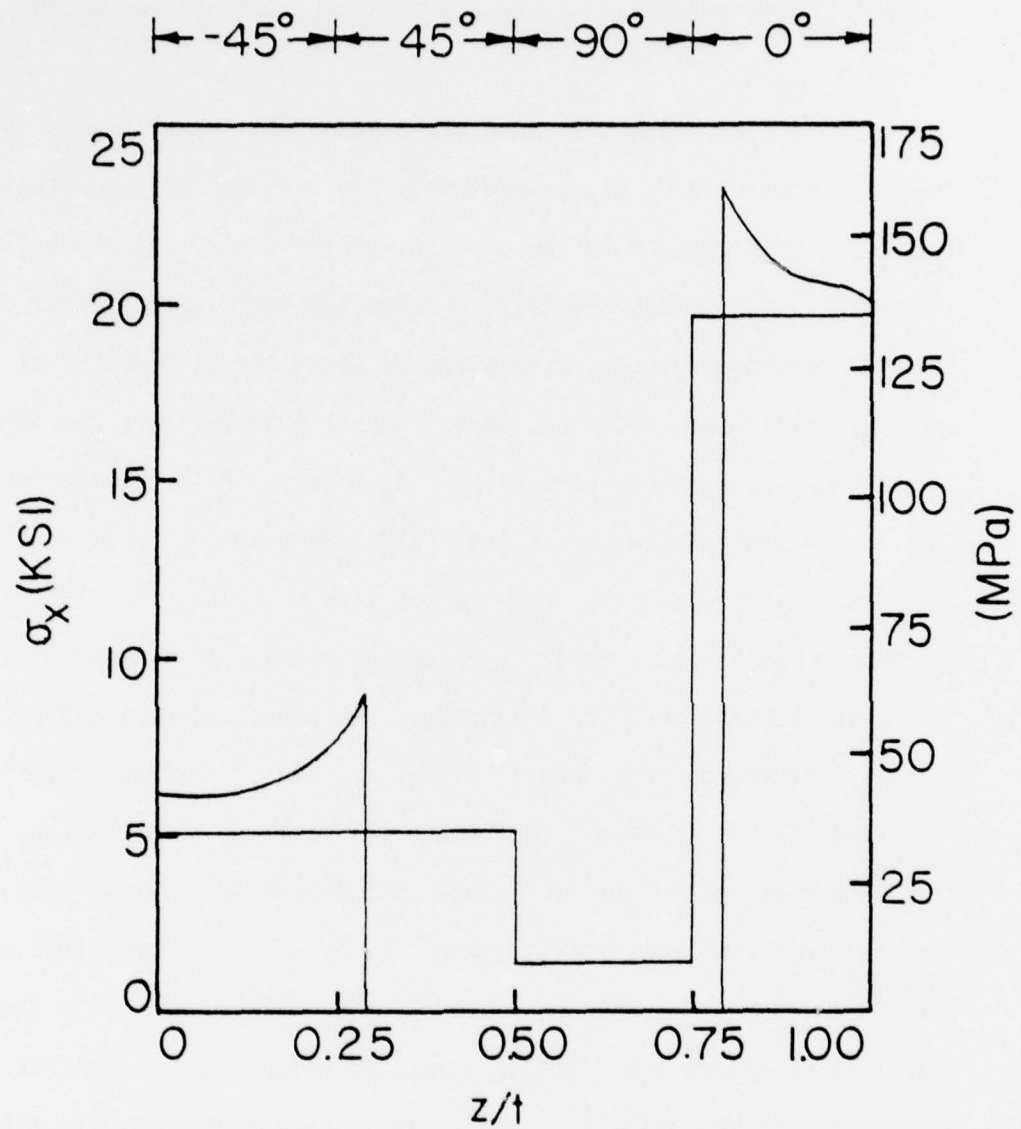
Figure 40. Through-the-thickness variation of  $\sigma_x$  for a type II laminate with 90° and 45° ply damage

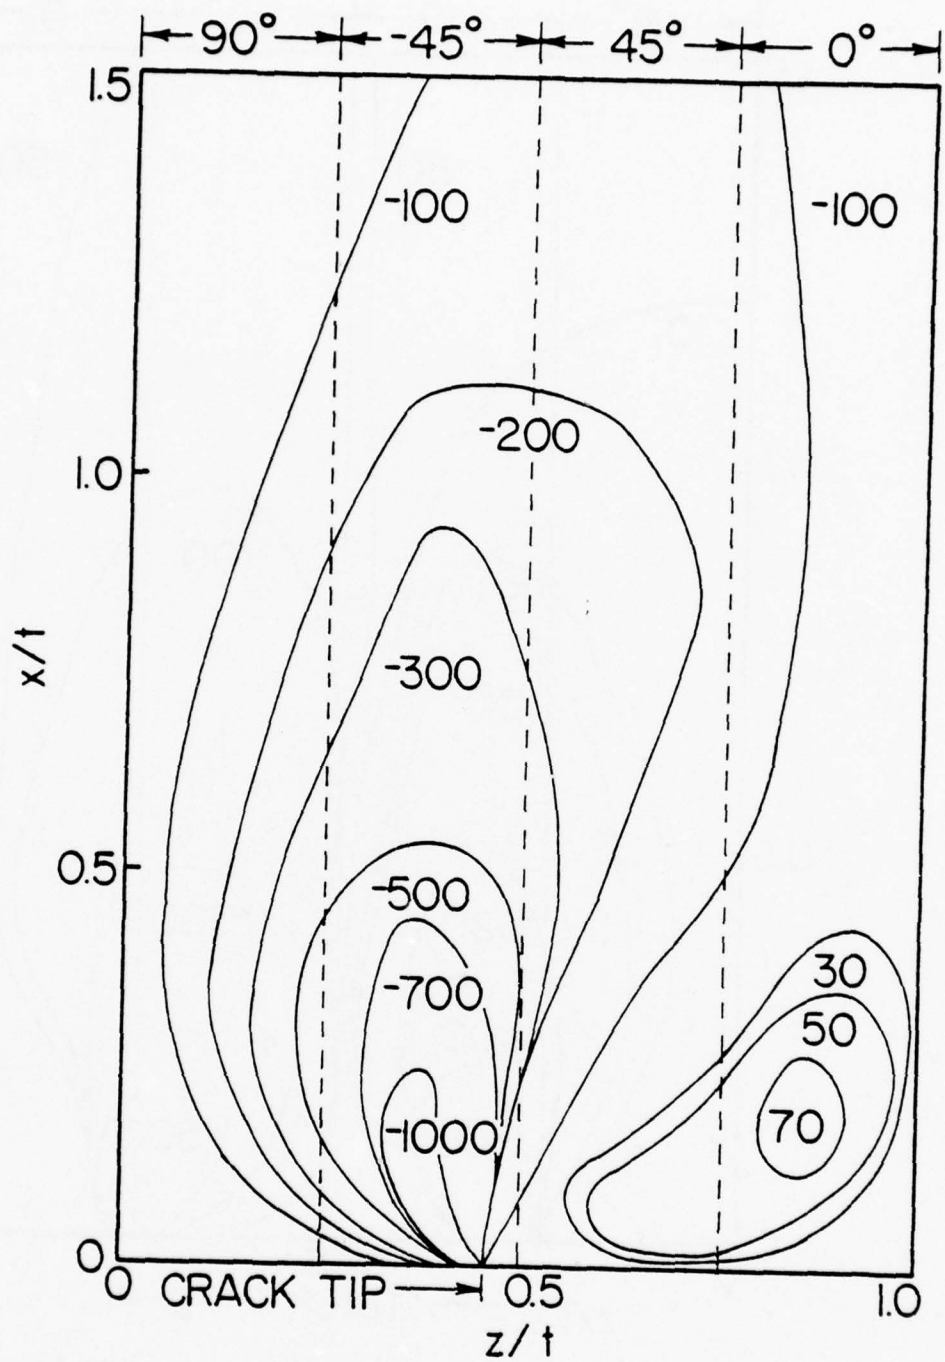
Figure 41. Contours of  $\tau_{xz}$  (psi) for a type I laminate with 90° and -45° ply damage
